## Case Study – Miller Homes, Park View

**Project:** Miller Homes North East, Park View Development, Gateshead

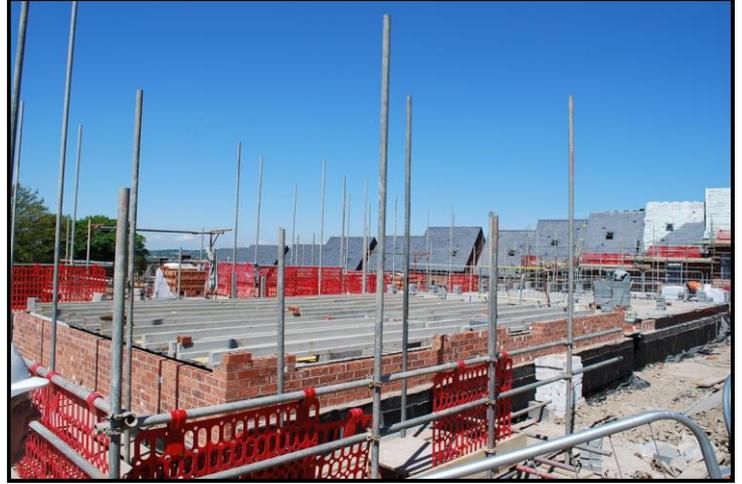
**Phase 1 – Construction**

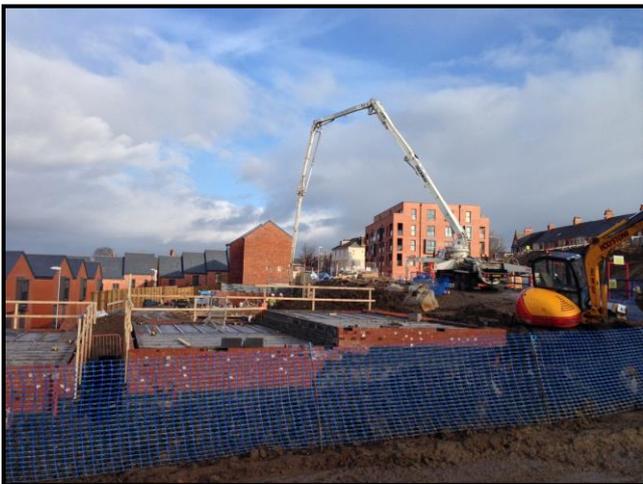
**Phase 1 – Construction with Herrington House in the background**

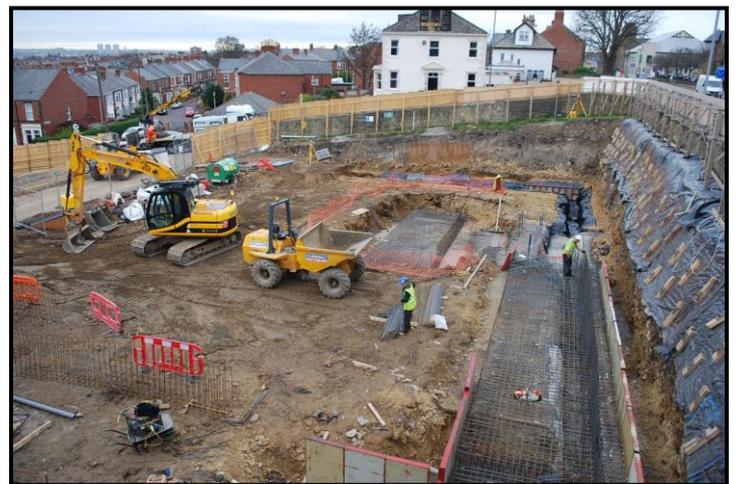
**Construction of the Retaining Walls**

Foundations comprise of strip foundations, retaining walls and ground bearing slabs in the case of partial basement garages.

The developers preferred structural form for Herrington House was that of load bearing masonry from ground level with a structural steel frame and reinforced concrete retaining walls forming the basement.

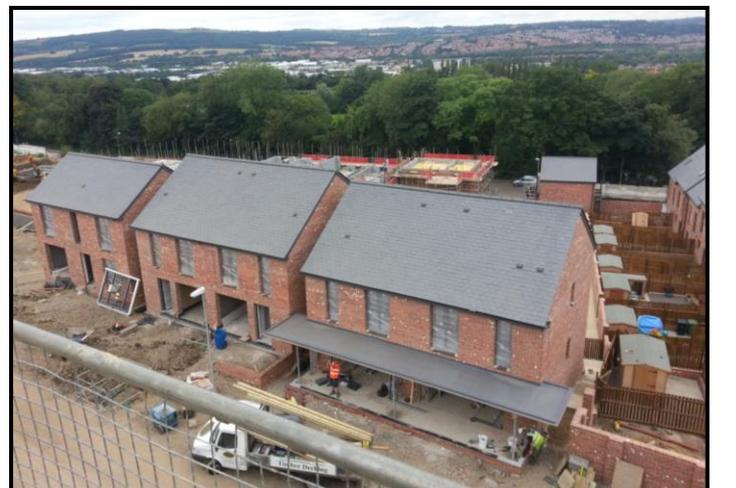
**Sales Office**

Of particular note was the adaption of a semi-detached dwelling to form the open plan temporary Sales Office, with an aim of being able to revert to two separate houses with minimum time and effort.
